**NASA TM X-58125
February 1974**

**PHOTODOCUMENTATION OF LONG-TERM
LUNAR SURFACE EXPOSURE EXPERIMENT**

**Friedrich Hörz
Lyndon B. Johnson Space Center
Houston, Texas 77058**

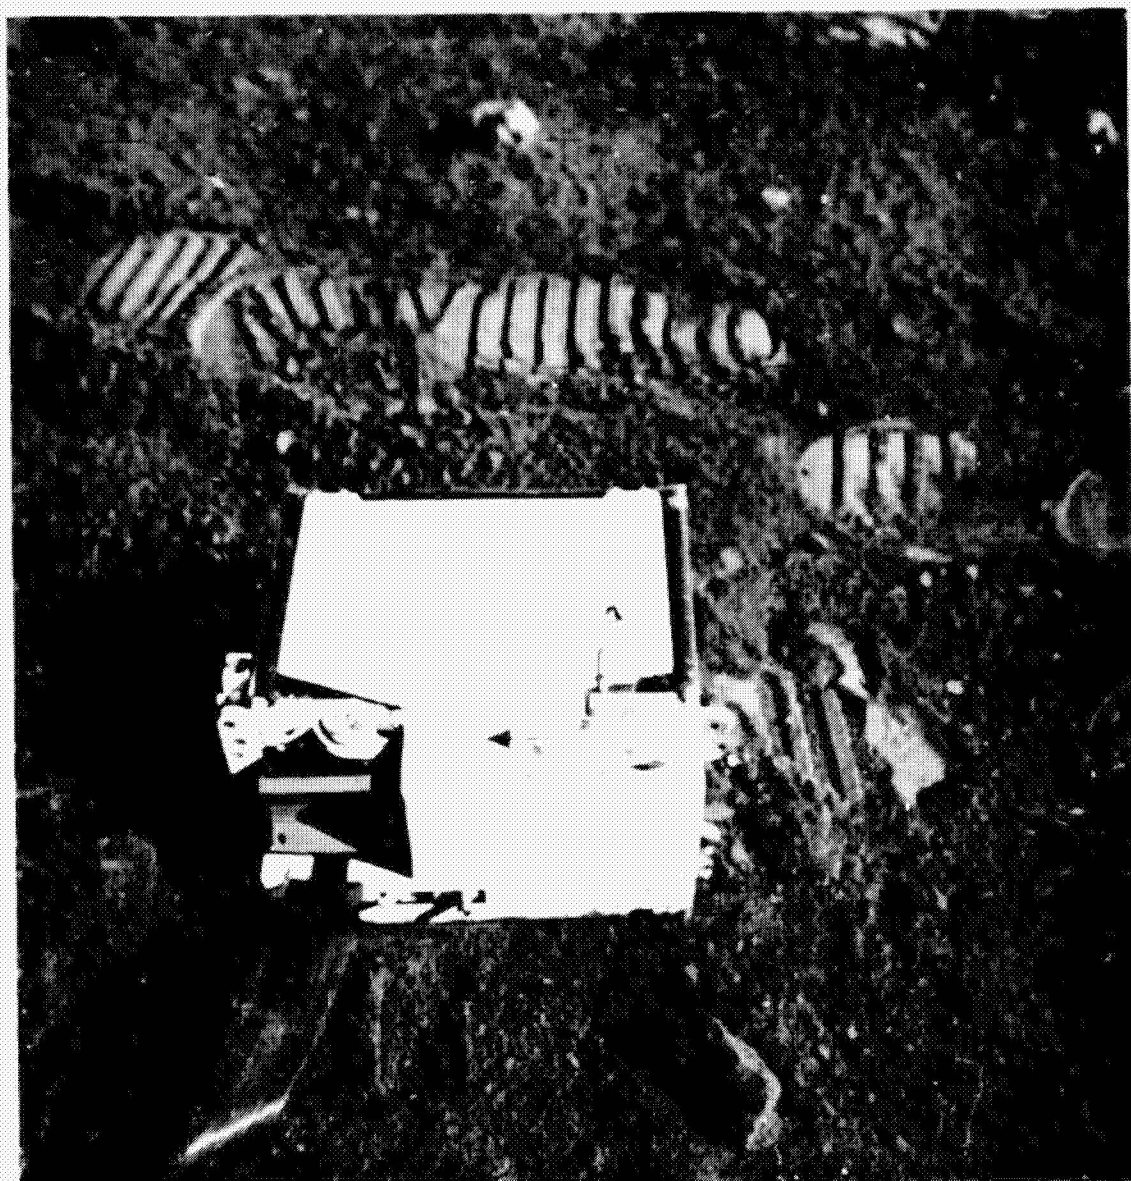
Figure 23. - Closeup photograph of the LACE (NASA AS17-134-20498).

The LACE and the SEP experiment solar cells are extremely well documented, whereas the positions and conditions of the LACE shield, the HAGH box, and the HFE electronics box are only approximately known. Unfortunately, no photographs of the various mirror surfaces were taken after the lunar roving vehicle (LRV) was parked at its final location. The Apollo 17 CTV camera was oriented horizontally; that is, at zero elevation and 318° azimuth (according to E. Fendell, JSC). The corresponding values for the identical Apollo 15 camera are 10° elevation and 276° azimuth; for Apollo 16, zero elevation and 100° azimuth. Originally, it was intended to strap one Hasselblad electric data camera to the tool pallet in the back of the LRV; however, because time was short, the commander placed it in his seat as vertically as possible. No photograph showing its precise position is available.

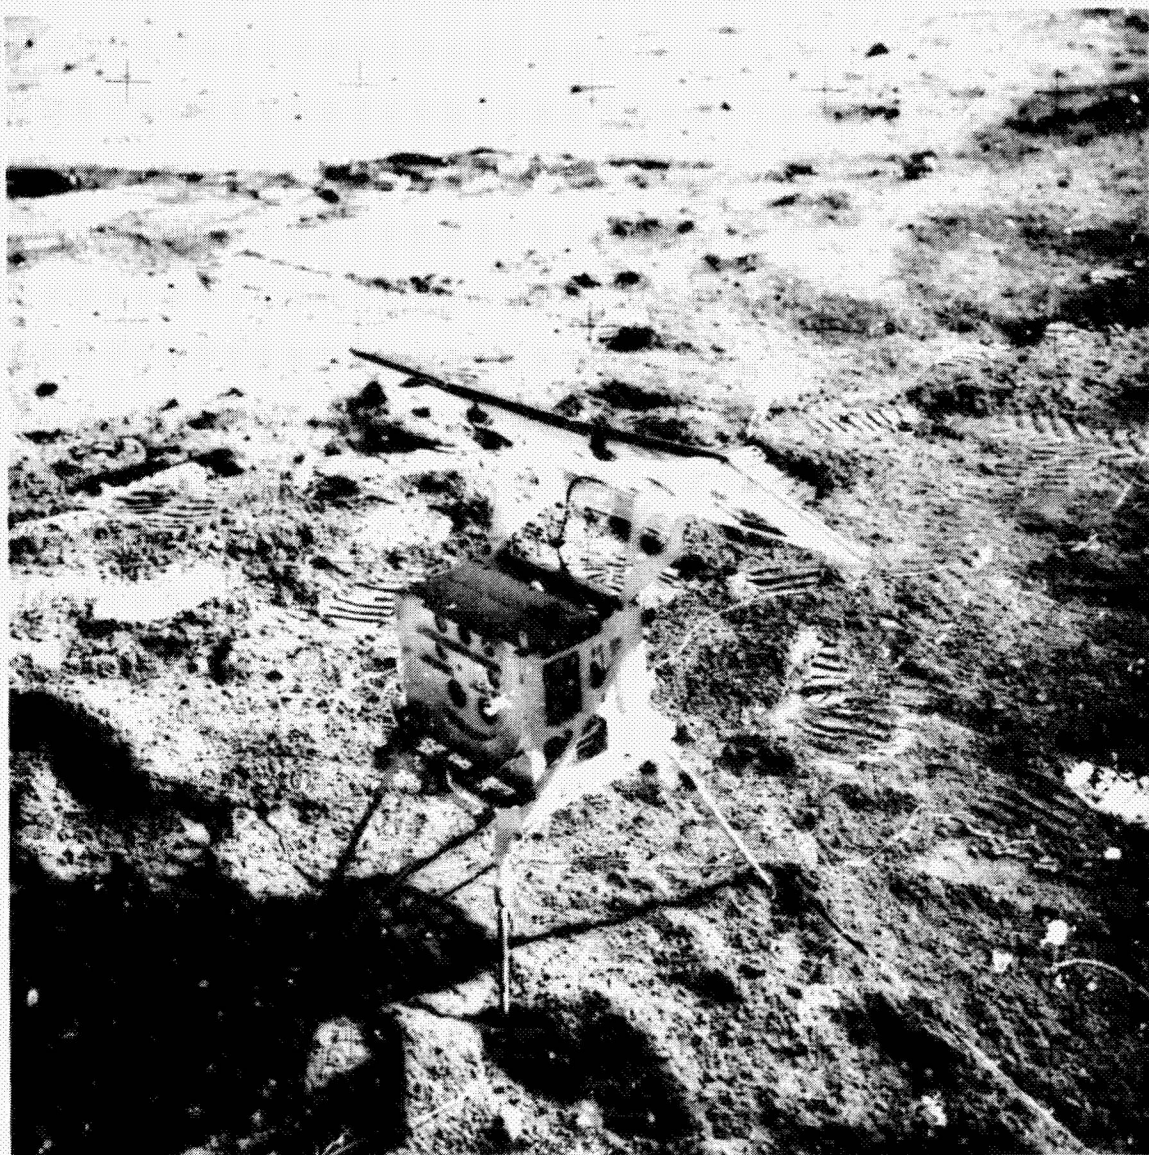
Figure 26. - Closeup photograph of deployed solar-cell array of the SEP experiment transmitter (NASA AS17-141-21510).

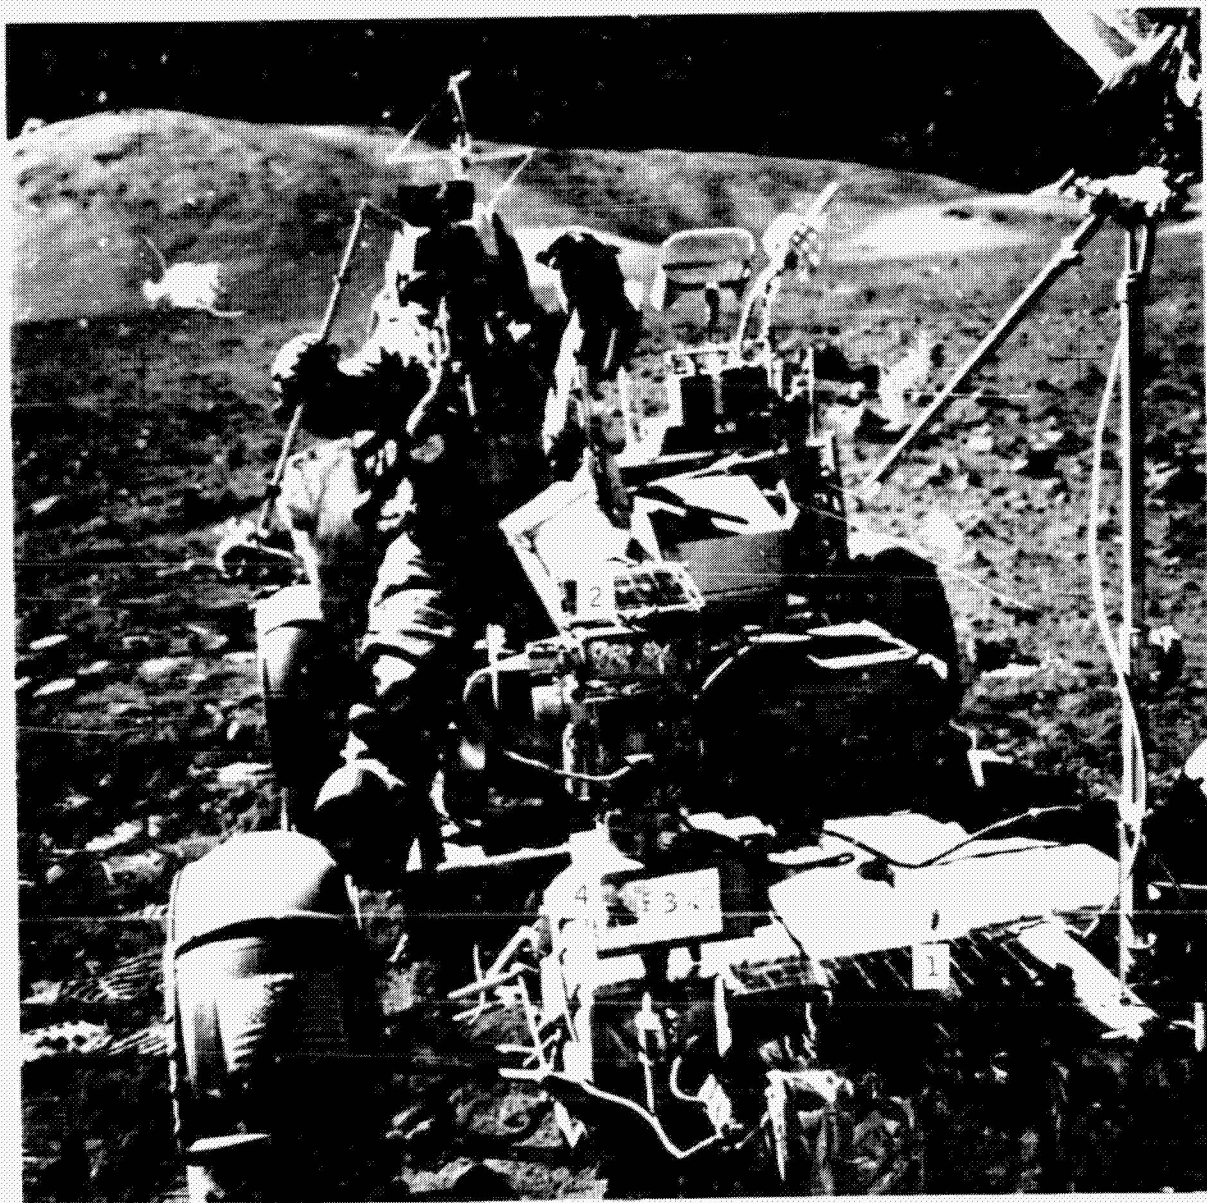
Figure 27. - View of the LRV displaying the arrangement of various documented mirror surfaces: (1) LCRU; (2) CTV, top mirror; (3) TCU, mirror A; and (4) TCU, mirror B (NASA AS17-134-20453).
